SERVICE MANUAL

MODEL 1701/1702 MONITOR

OCT. 1984 PN-314004-01

#### Commodore Business Machines, Inc.

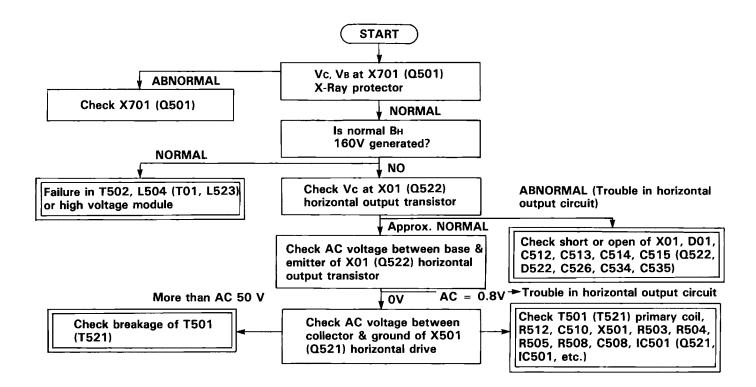
# No raster, no sound (B<sub>1</sub> is normal)

Problems in the horizontal deflection circuit hinder generation of high focusing voltage, BH 160V and B2 12V, resulting in no raster, no sound.

- 1. As long as normal BH 160V is generated, the horizontal output circuit properly operates, producing pulses during the flyback period of the saw-tooth wave current passing through the horizontal deflection coil. If a problem is found with normal BH voltage, the problem area should be the secondary coil of the flyback transformer.

- 2. When the AC voltage between base and emitter of the horizontal output transistor X01 (Q522) is about 0.8V, it is supplied with input pulses. The problem is therefore in the horizontal output circuit. When, however, X01 (Q522) is shorted, this AC voltage is not indicated even if there are input pulses at X01 (Q522).

- 3. AC voltage is measured between the collector and ground of X501 (Q521) horizontal drive as shown. When the specified voltage is shown on the meter, the horizontal output circuit is the problem; while, when there is no voltage indication, the trouble is in some element(s) preceding X501 (Q521). Check if those transistors and ICs are damaged using a voltage measurement.

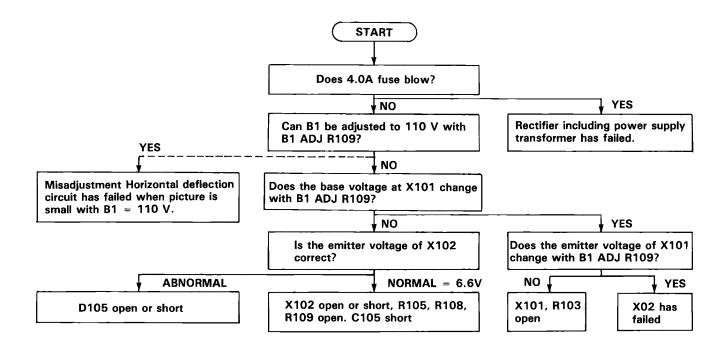
# No raster, no sound (B<sub>1</sub> is abnormal)

Abnormal B<sub>1</sub> voltage indicates trouble in the power supply circuit. When B<sub>1</sub> voltage is not only low but also abnormally high, X701 (Q501) of the X-ray protector is turned on, setting the collector voltage to 0 V. The horizontal oscillator is then disabled resulting in no raster and no sound.

- When D105, R105, R108, R109 are open, the base voltage of X101 and X102 rise to increase B1 voltage to more than 130V. This causes the X-ray protector to work, resulting in no raster.
- 2. If the base voltage drops as when R103 is open or C105 is shorted, the B<sub>1</sub> voltage is reduced to less than 40 V. This will mostly result in no raster, no sound.
- When the B<sub>1</sub> voltage drops to about 70 V, because R910 is open and D105 is shorted, the screen becomes dark and the raster size is reduced because of insufficient horizontal and vertical amplitude.

1702 locations in ( ). The regulator PCB assembly used in 1702 models differs from the 1701 power PCB assembly. The B<sub>1</sub> voltage circuits should be checked beginning with IC901.

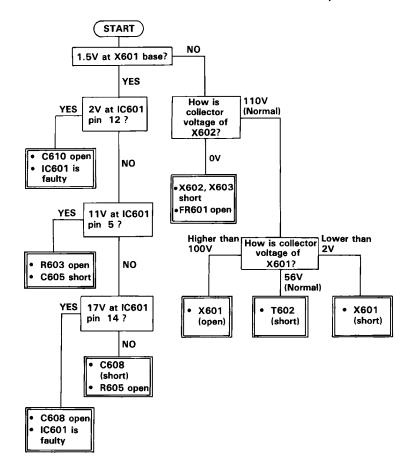
# No sound (with normal picture)

[Cause] Trouble in the audio circuit IC601, X601, X603 or X604 are faulty.

1702 — Audio circuit has been reduced to IC601.

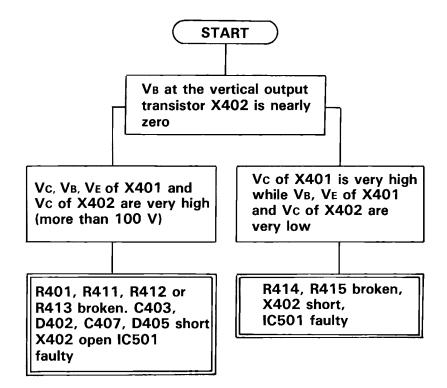
# Only single horizontal line, normal sound

[Cause] Malfunction of the vertical deflection circuit. When the vertical deflection circuit is faulty, saw-tooth current is not applied to the vertical deflection coil, resulting in a single horizontal line. During troubleshooting, reduce brightness contrast to prevent an ion spot on the CRT.

- 1. R401 broken, C403, D402, C413 short: B2 12V is not supplied, disabling IC501.
- 2. R411, R412 broken, C407 short: the voltage at IC501 pin 3 is set to zero disabling the V-amplifier and the voltage at pin 2 is set to zero to turn off X402.
- 3. R414, R415 are broken: VB of X401 is zero disabling X401 and X402.
- Also check if C402 is short or open.
- 5. Too high VB of X402 is because of C401 short or failure in IC501 or X402.

Note: When the voltage generator fails to supply B2 12V to the secondary coil of the flyback transformer of the horizontal output circuit due to malfunction, a single horizontal line and no sound will result.

- **NOTE: 1701** First check if FR401 is broken or not. If this is broken, the trouble is due to short of X401 or break of D401.
  - 1702 Circuits in 1702 monitor differ but the operation remains the same. Check vertical controls/deflection circuits.

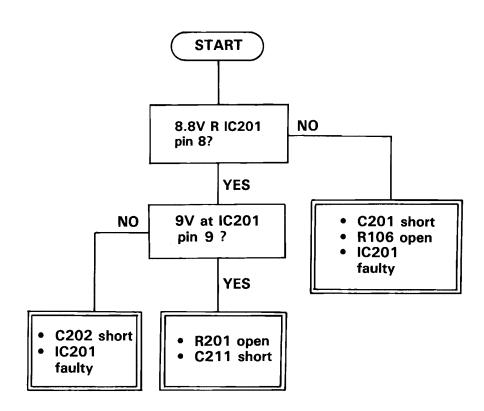
# Improper horizontal or vertical synchronization

The sync separator and amplifier consists of an IC(IC201). The main cause of failure is often a failure of the IC itself. It is also necessary to be careful of a possible failure of the external components. Because the change of voltage at each pin of the IC is extremely small, it is very difficult to discover a failed element by measuring voltage.

This is due to a failure of IC501 or the horizontal AFC circuit.

This is due to a failure of either the separator and amplifier for the vertical synchronous signal, or the vertical oscillator IC501 and its peripheral elements.

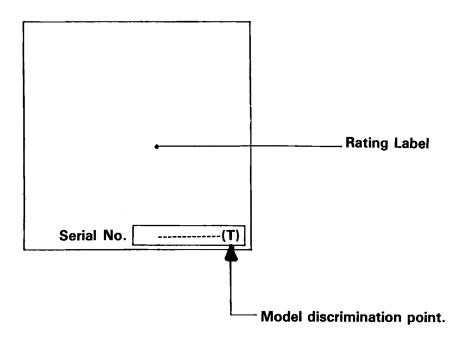
#### 1702 MODEL IDENTIFICATION

Some models are distinguished with the letter "T" next to the manufacturer's serial number.

This designation indicates that a TOSHIBA picture tube and deflection yoke were used. A difference in electrical specifications is required. The connect schematic and parts list is identified 1702 "T".

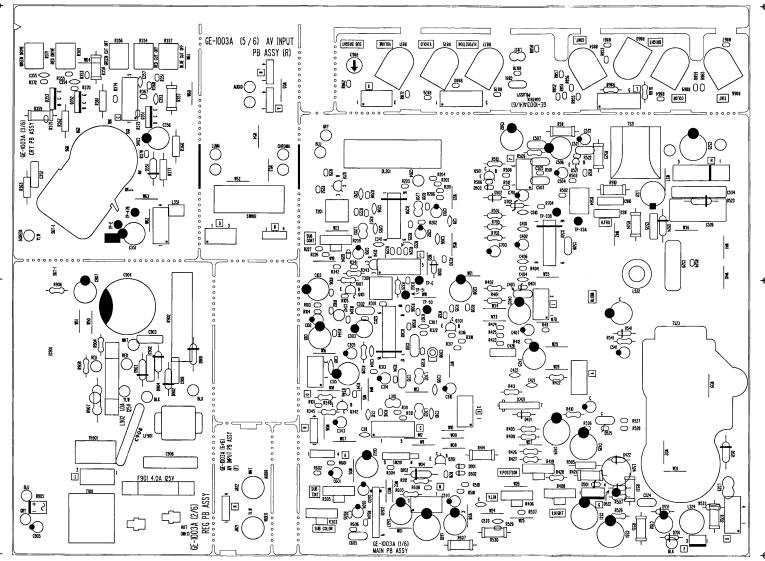
#### 1702 Schematic Notes

VOLTAGE & WAVEFORM NOTATIONS — Voltage readings and waveform measurements were taken with a color video signal injected at the video input terminal. Each variable resistor was set to condition at time of shipment. After adjustments have been made, the figures will vary and the figures should be used for reference only.

Resistors : All values are in ohms, 1/6 watt carbon.
Capacitors: Values of 1 or higher are pF.
Values less than 1 are µF, 50V, ceramic.
Electrolytic values are in µF, NP indicates non-polar (bip Inductors: Values are in µF)

indicates a test point connection
 indicates chassis ground
 Hz indicates cycles per second
